**U.S. Environmental Protection Agency
Vasquez Boulevard I/70 Superfund Site
Replacement Certificate**

4723 Vine St.

3557

SITE NAME: VASQUEZ BOULEVARD AND I-70

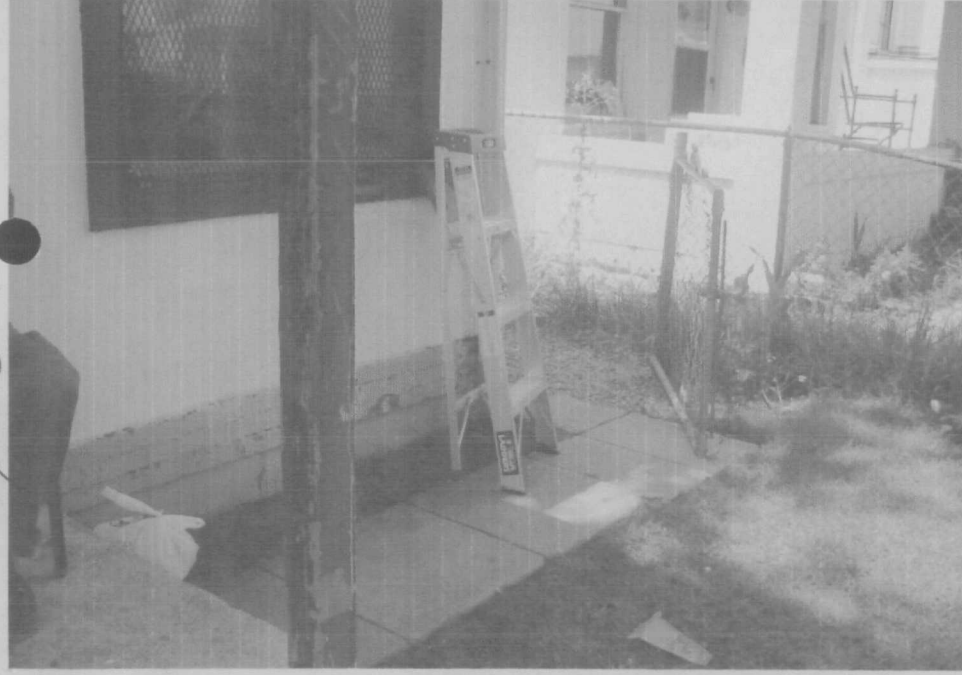
photo 1

Drawing Number	Photo Number	Painted Surface	Material	Color	Total Area of Element (units ft^2)	Percent Deteriorated	Deteriorated Area (units ft^2)	XRF #	XRF Value	pos/neg	Notes		
1	1	Front porch posts (2)	wood	green	19.50	50%	9.75	43	12+-3.2	pos			
2	2	foundation wall	brick	gray	16.30	100%	16.30	44	2.7+-1.3	pos			
		window trim	wood	green			1.40	45	0.03+-0.18	neg			
3	3	porch soffit	wood	white			1.00	47	11+-3.2	pos			
4	4	gable, gable soffit, gable trim	wood	white	99.70	25%	24.93	see 47	11+-3.2	pos			
Address: 4723 Vine		Structure:		House									
Date: 8/5/05		Direction:		North									
Investigator: CM/WH													
Time Started: 12:30 pm
